บริษัท โตเกียวเอ็นจิเนียริง จำกัด.
TOKYO ENGINEERING CO., LTD.

Type Standard Size (Straight Thread)

Type Over Size (Enlarged)

Cold Press Coupler ต่อข้ออ้อยแบบบีบ

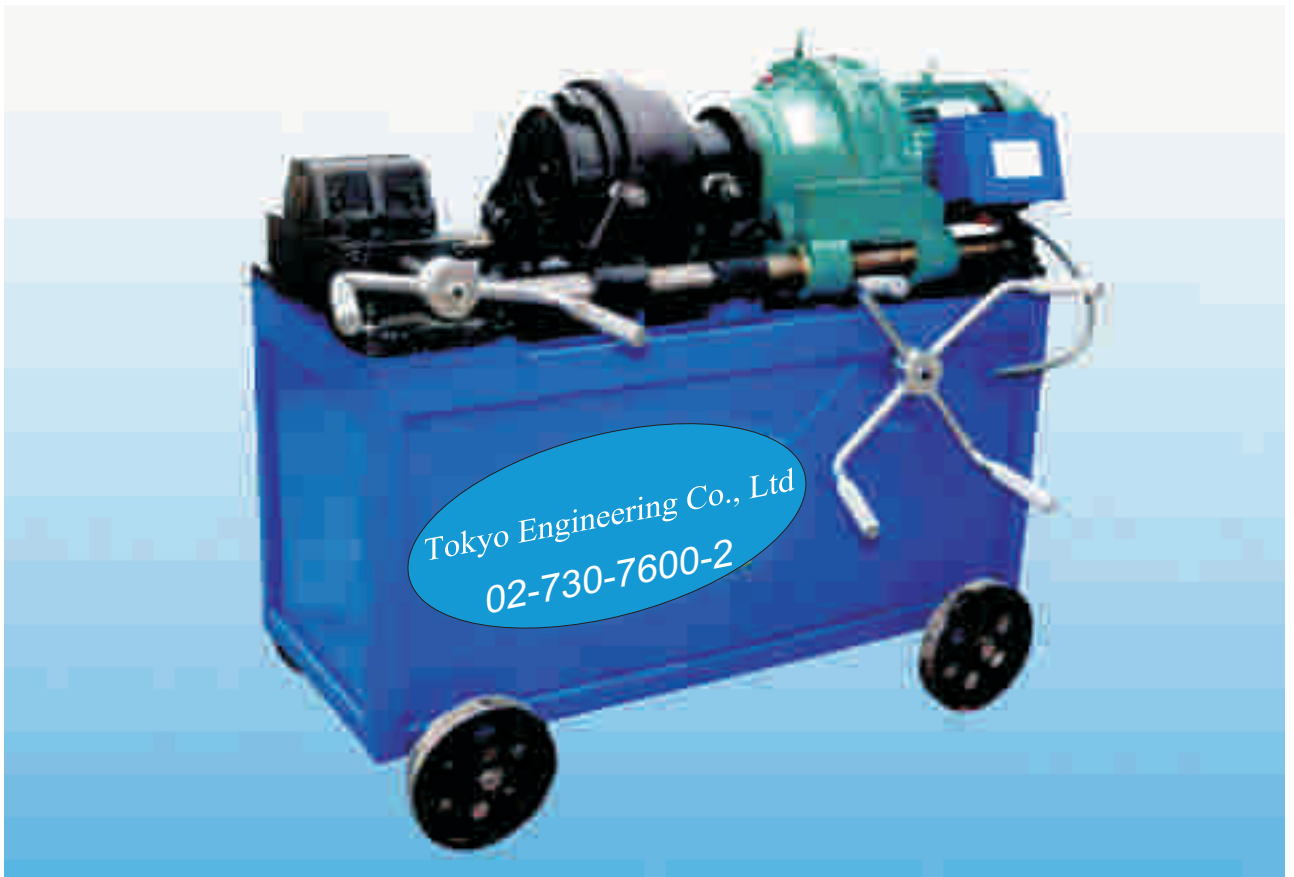
ใช้งานสะดวก แม่นยำ แน่นอน กินพื้นที่ ไม่เกิน 2 ตารางเมตร

Easy for use Machine work Stable Work in Small area

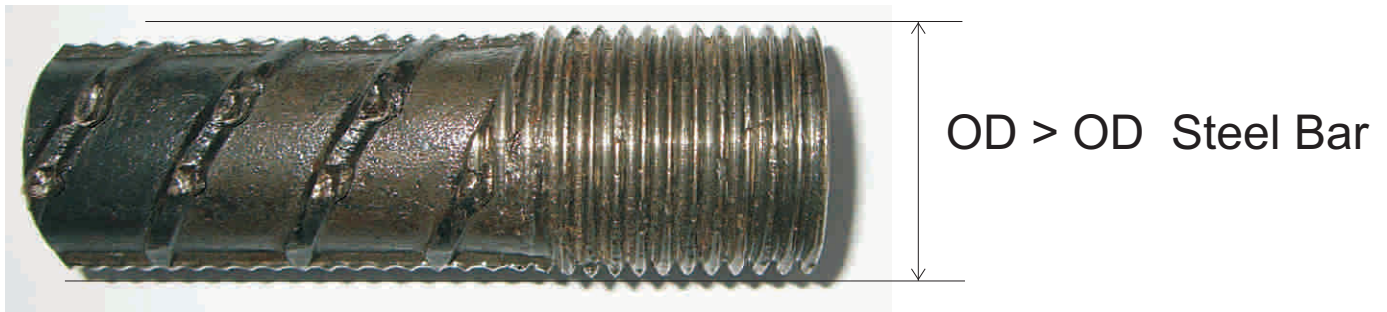
รูปแบบเกลียวตรงขยายหน้าตัดเหล็ก

Specification Of Over Size Coupler

Deformed (Reinforcing) Bar Size	DB 16	DB 20	DB 25	DB 28	DB 32	DB 36	DB 40
Finishing Thread Size	M18x2.5	M22x2.5	M28x3.0	M32x3.0	M36x3.0	M40x3.0	M44x3.0
Coupler Yield Load	13,989	21,392	29,918	35,928	43,659	51,529	70,099
Coupler Ultimate Load	22,290	31,687	47,318	57,865	68,855	81,589	110,685

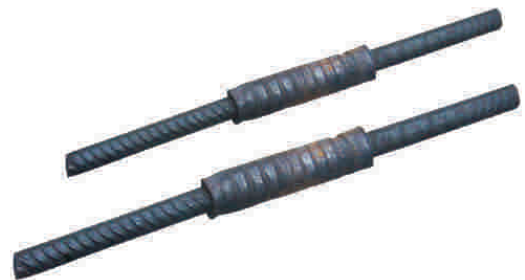
Specification Of Cold Press Coupler

Deformed (Reinforcing) Bar Size	DB 16	DB 20	DB 25	DB 28	DB 32	DB 36	DB 40
Coupler Length	100	110	150	170	180	210	250
Coupler Yield Load	17,399	21,492	31,758	38,028	53,659	68,289	83,099
Coupler Ultimate Load	27,890	34,387	50,318	60,865	86,155	109,589	132,685
Press Time	2x2	3x2	4x2	5x2	6x2	7x2	8x2

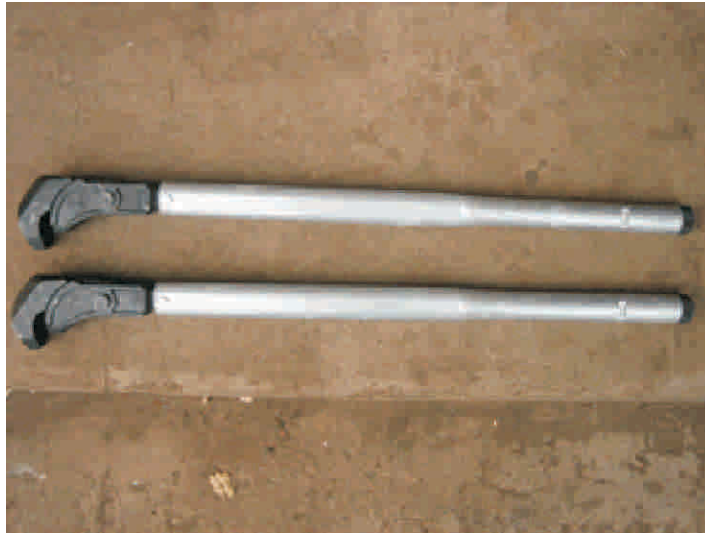
Torque Wrench for Reformed bar

Coupler Torque Data (N/m)

Size of D-Bar	12-16	18-20	22-25	28-32	36-40
Torque (N-m)	80	160	230	300	360
